Monitoring and Purification Data

## iCon Air Heater Before vs After Install Data

# Miami Beach Convention Center

# CBRE Open Office Setting

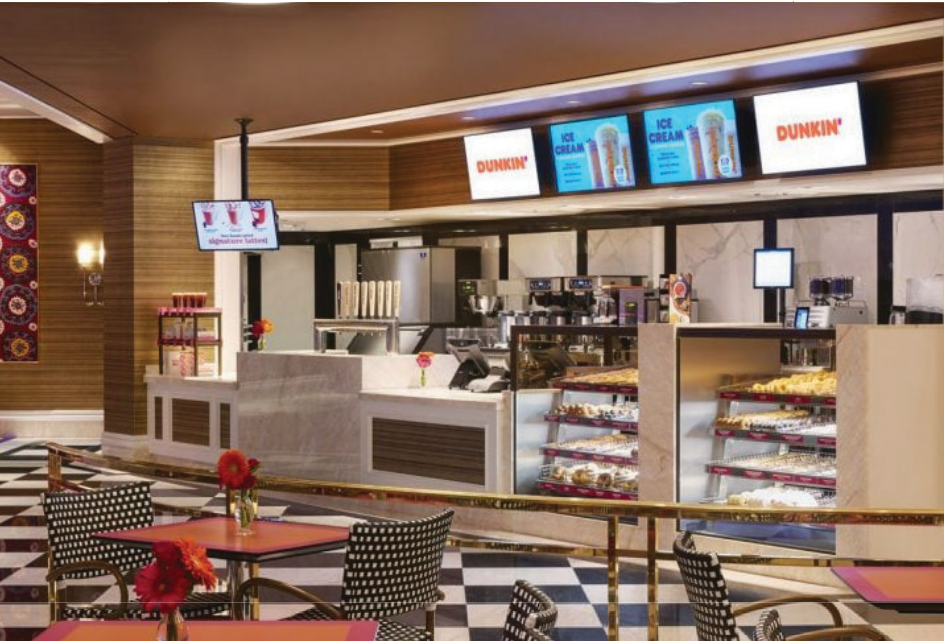
Air quality data from a 4,500 square foot Dunkin' Donuts restaurant that had installed a competing air purification system which uses bi-polar ionization technology to purify the air.

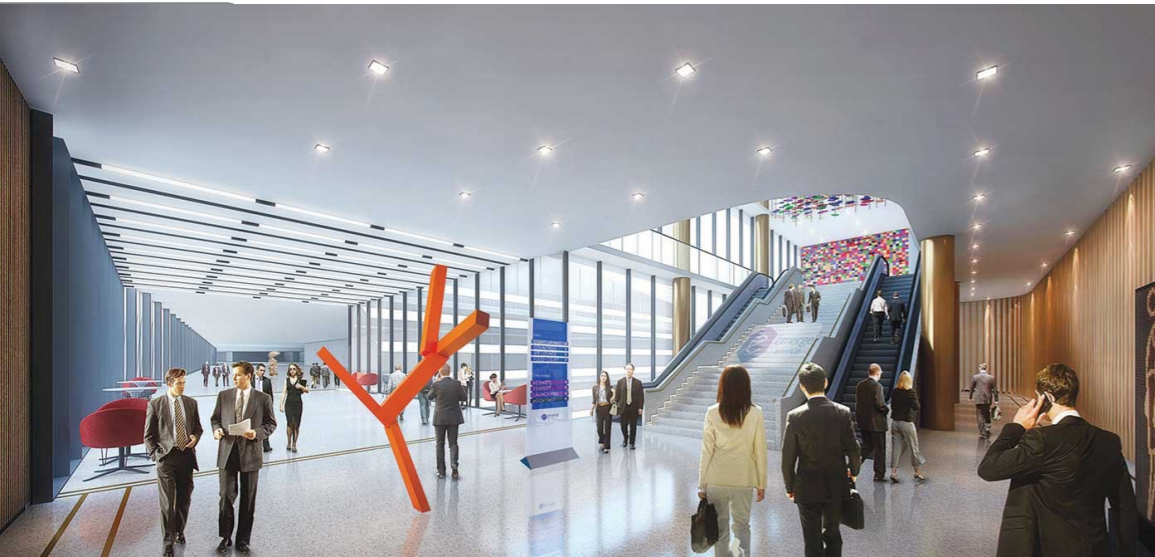
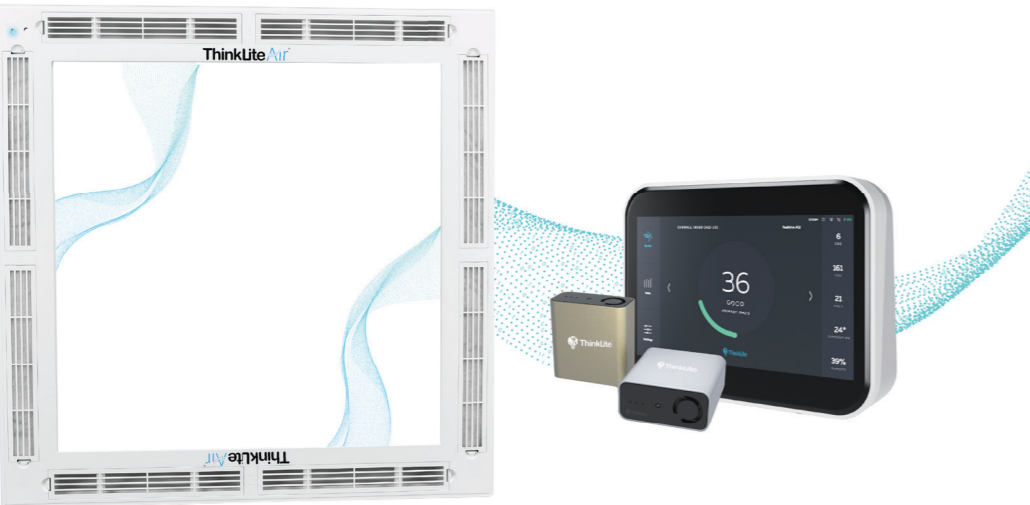
The air quality quickly deteriorates as soon as the Purilux is switched off, and gradually gets worse over time through the night, even though there is a lack of foot traffic at the convention center during those times.

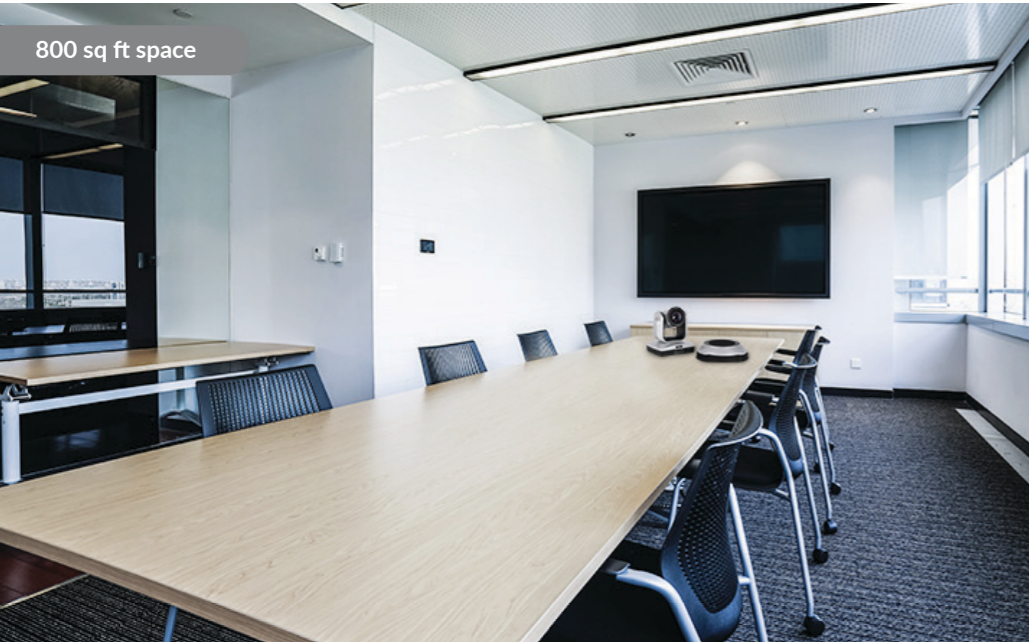
**Hillside Conference Room BEFORE**

Air quality data from an 800 square foot conference room at Hillside that does not have air purification.
